Groundline Pty Ltd - Observations

Site Visit 1: Scoping & Initial Investigation

Project: "Data Calibration Project
– Initial Investigation

Sites are located along the xxxxxxxxxxxx line . Tower Foundations reviewed are **358D** and **299A** (*As identified in previous Groundline report AU xxxx, June 05*). Locations are approximately xxkm south of xxxxx along the xxxx Highway.

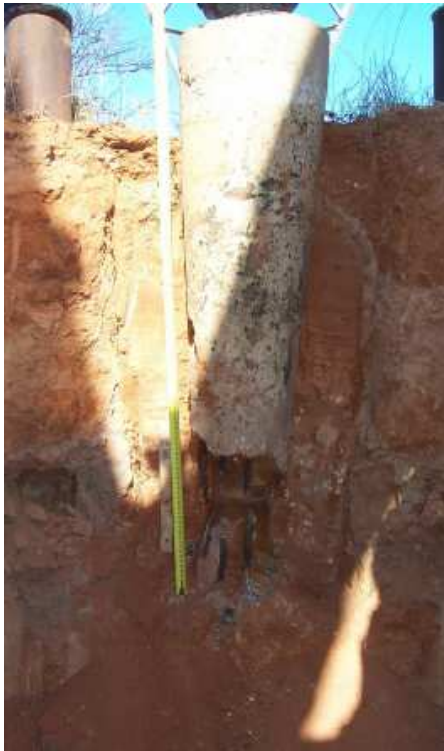
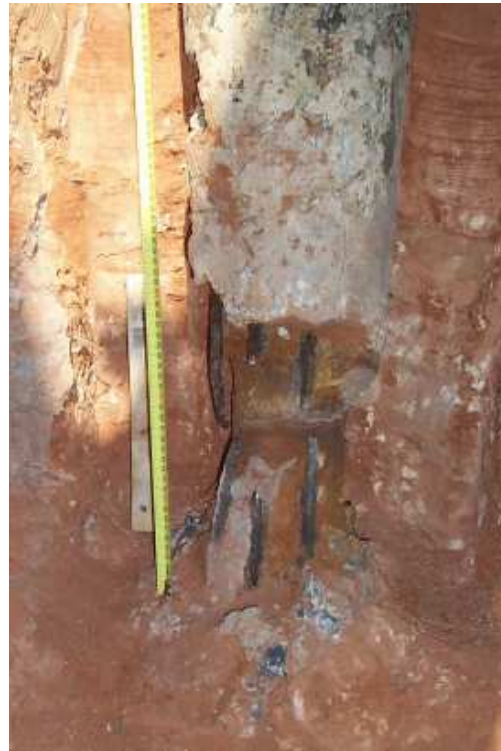
Tower 358 Leg D

Foundation section badly deteriorated at 1m from pile-cap. Significant loss of concrete was observed with complete corrosive loss of reinforcement steel. The tower leg is visible in the above pictures.

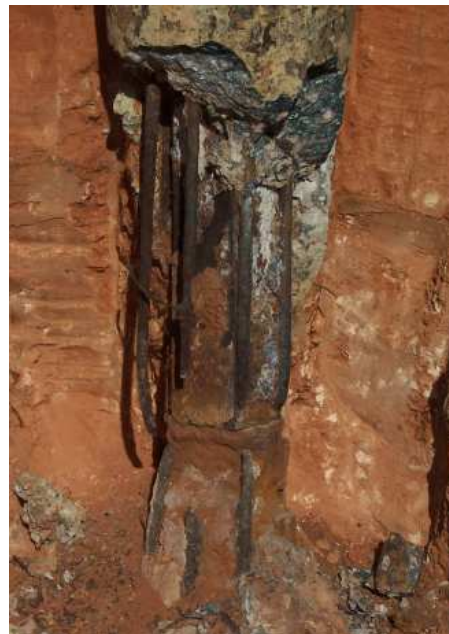
On further close review, a quick chip at a section above the immediately visible defects uncovered further hidden damage.

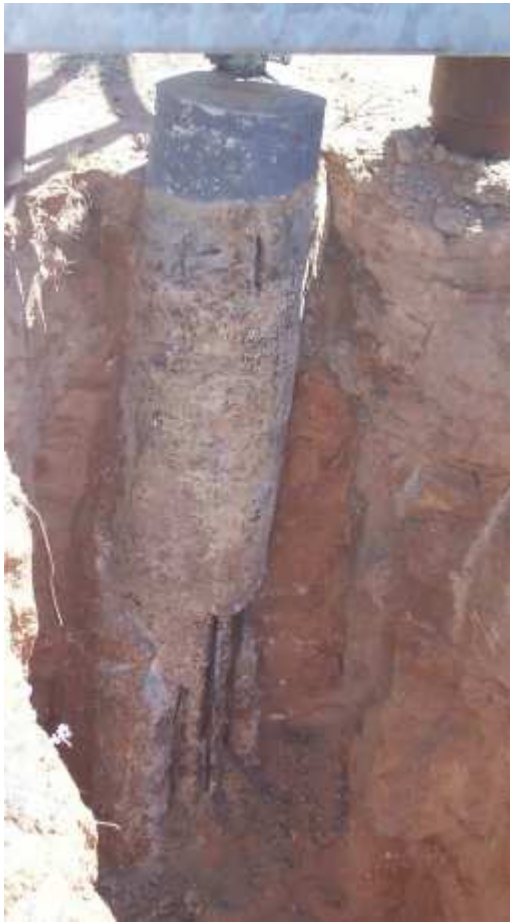
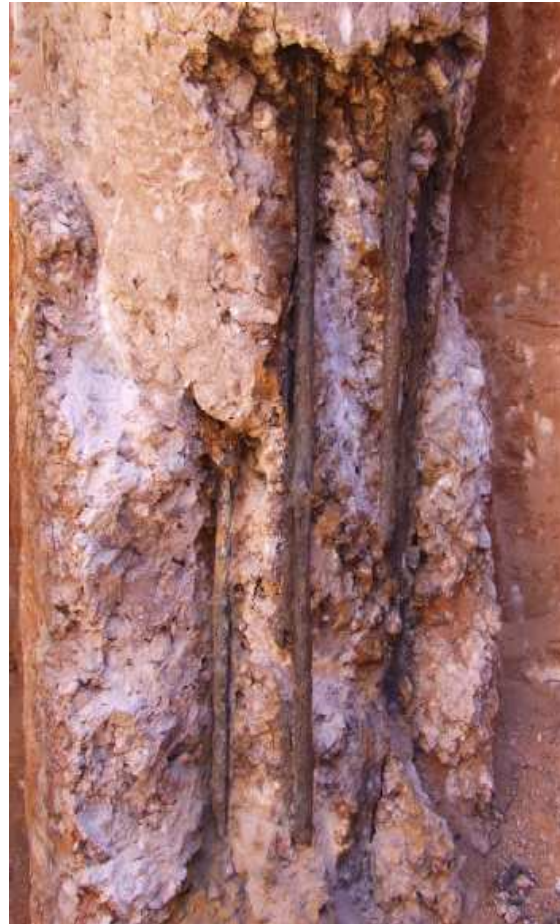
Tower 299 Leg A

Foundation shows deterioration of concrete at 1200mm below pile cap resulting in significant loss of steel cover. The four visible reinforcing rods have been corroded through. Concrete quality at the 1200mm to 1400mm level is of poor quality.
